## PERFORMANCE EVALUATION OF THE CARTER FABRICATING INC. "EVO RIVETLESS PANEL SYSTEM" WALL ASSEMBLY FOR AIR INFILTRATION, WATER PENETRATION AND STRUCTURAL PERFORMANCE

Report to:	<b>Carter Fabricating Inc.</b> 326 Deerhurst Drive Brampton, Ontario L6T 5H9
Attention:	Mr. Bruce Bourne
cc.:	Mr. Mike Libreiro
Telephone:	(905) 487-1684 Ext. 101
E-mail:	bbourne@carterfabricating.com
Telephone:	(905) 487-1684 Ext. 103
E-mail:	mlibreiro@carterfabricating.com
Report No.:	15-06-M0134 9 Pages, 2 Appendices
Proposal No.:	15-006-361503
Date:	June 17, 2015

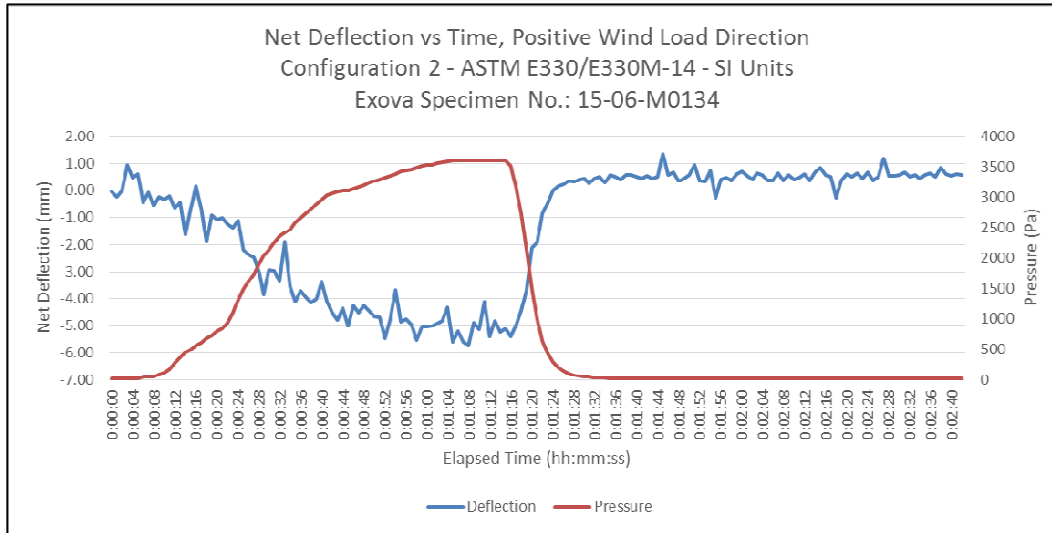
Figure No. 1 – Net Deflection vs Time, Positive Wind Direction, SI Units

Table No. 5 - Summarized Structural Results, Positive Wind Load Direction Configuration 2 – ASTM E330/E330M-14 – SI & IP Units Exova Specimen No.: 15-06-M0134 (Test Date: June 3, 2015)				
Pressure (Pa)	Gauge No. and Deflection			
	1	2	3	Net Deflection
3,591 Pa <sup>(1)</sup> (75.0 lbs. /ft <sup>2</sup> )	-1.4 mm (-0.057 inches)	-6.5 mm (-0.257 inches)	-1.3 mm (-0.049 inches)	-5.2 mm (-0.204 inches)
Residual Deflection	-1.6 mm (-0.063 inches)	-0.3 mm (-0.012 inches)	-0.2 mm (-0.008 inches)	0.6 mm (0.024 inches)

Positive Loading Net Deflection Design Load: (+3591 Pa) = 5.2 mm < 13.6 mm Requirement  
Negative Loading Net Deflection Design Load (-3591 Pa) = 6.6 mm < 13.6 mm Requirement

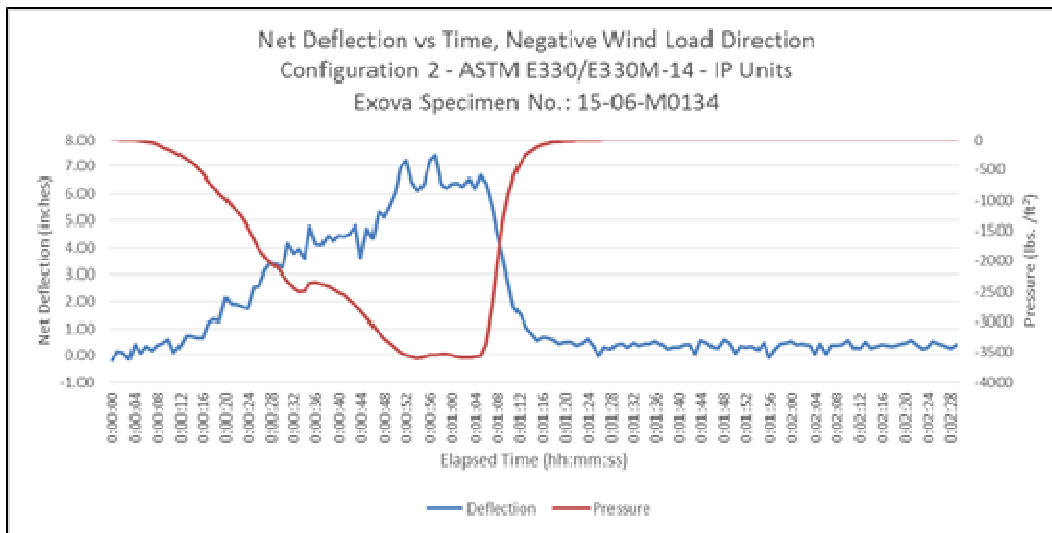
Figure No. 4 – Net Deflection vs Time, Negative Wind Direction, IP Units

Table No. 6 - Summarized Structural Results, Negative Wind Load Direction Configuration 2 – ASTM E330/E330M-14 – SI & IP Units Exova Specimen No.: 15-06-M0134 (Test Date: June 3, 2015)				
Pressure (Pa)	Gauge No. and Deflection			
	1	2	3	Net Deflection
3,591 Pa <sup>(1)</sup> (75.0 lbs. /ft <sup>2</sup> )	-0.1 mm (-0.003 inches)	7.1 mm (0.281 inches)	1.3 mm (0.050 inches)	6.6 mm (0.258 inches)
Residual Deflection	-0.1 mm (-0.006 inches)	0.3 mm (0.014 inches)	0.1 mm (0.004 inches)	0.4 mm (0.015 inches)

Positive Loading Net Deflection Design Load: (+75.0 lbs. /ft<sup>2</sup>) = 0.204 inches < 0.536 Inch Requirement  
Negative Loading Net Deflection Design Load (-75.0 lbs. /ft<sup>2</sup>) = 0.258 inches < 0.536 Inch Requirement

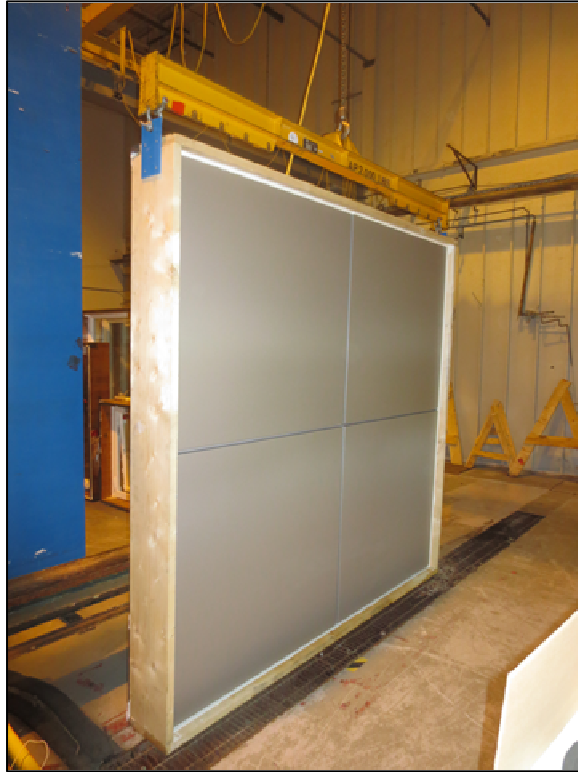
Figure B1 – Test Specimen (Exterior View)

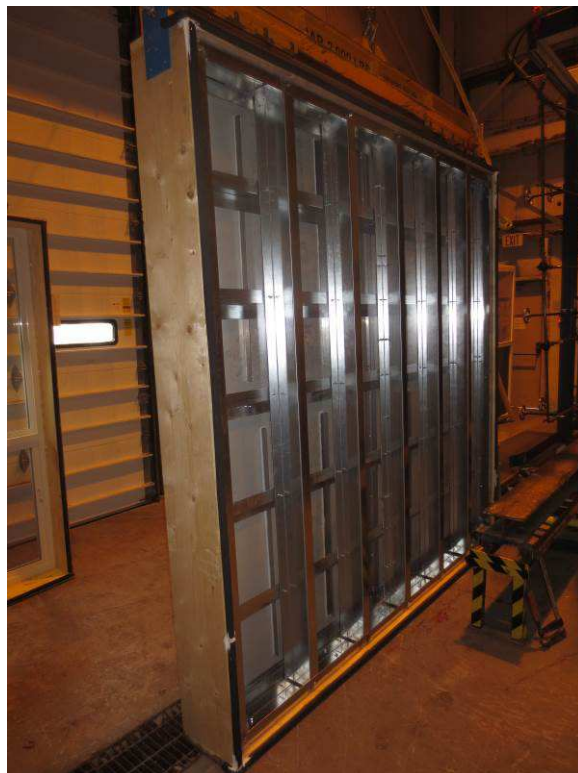
Figure B2 – Test Specimen (Interior View)
